DAMAGE INSPECTION OF COTTON MODULE COVER USING MACHINE VISION

Hsiang-Yun Chang
Stephen W. Searcy
Texas A&M University
College Station, TX

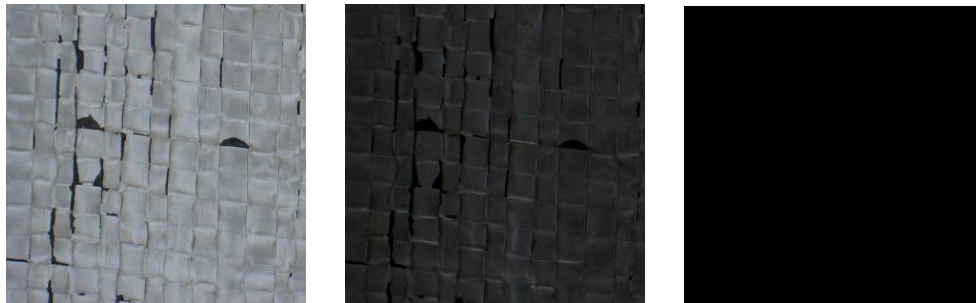
Figure 5. a) A small region of a module cover, b) the same region with back light applied, c) binary image after automatically pinhole detection.

The tested samples included different types, woven, film and vinyl covers. The cases where predicted water penetration was lower than the actual water penetrations usually happened on the woven covers, for the other two types of covers, the number of pinholes and water penetrations had a higher correlation. Figure 5 shows the images from a woven cover where 5(a) is a normal reflected light image in which the degraded cover layer can be seen, 5(b) is the cover with back lighting and 5(c) is the binary image after automatically threshold selecting. The coating was obviously decayed and peeled off; however, the back lit visual inspection showed no pinholes on the cover. This kind of situation happened on a portion of woven covers, but not all of them. Depends on the condition of the cover, some coating will be decayed and cracked while other regions are intact. Figure 6 shows a cover section that with a high water penetration that does result in pinholes in the binary image. Under the back lit situation (figure 6(b)), some white spots can be seen in the grey level image. The greater agreement between predicted and actual water penetration suggests that for this type of covers, direct paths through pinholes are the major channels of water penetration instead of indirect paths between cracked coating and fibers.

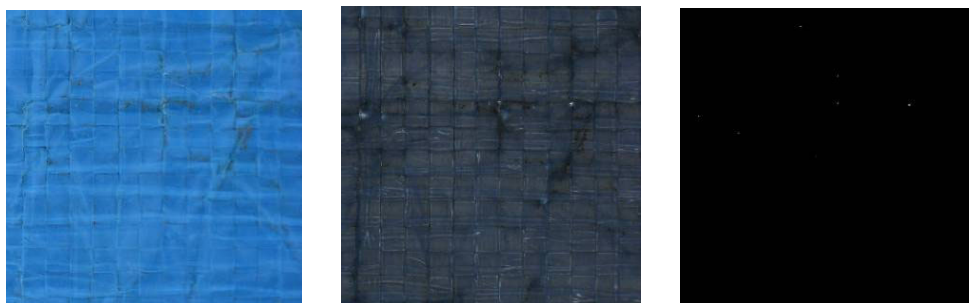
Figure 6. a) A small region of a module cover, b) the same region with back light applied, c) binary image after automatically pinhole detection (pinholes are present, although they may not be visible due to image resolution).
