# REMOVAL OF PLASTIC SHEET MATERIAL WITH NORMAL COTTON GINNING EQUIPMENT

R. K. Byler J.C. Boykin R. G. Hardin IV USDA ARS Cotton Ginning Research Unit Stoneville, MS

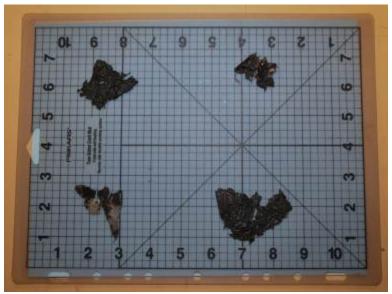
Figure 2. Dark plastic material found in a bale of U.S. cotton by a mill. Courtesy of Lance Murchison, National Cotton Council.

Some sheet plastic material is removed by cotton ginning equipment but some of the plastic has been found in the lint by mills, Figures 1 and 2. The gin cleaning equipment was designed to remove plant parts from the seed cotton, cylinder cleaners generally remove smaller plant parts such as leaf parts and extractors generally remove larger and heavier material such as hulls. However, no references were found regarding the removal of sheet plastic material from the cotton stream in the gin plant. The purpose of this study was to obtain data to better understand the removal of sheet plastic material from the cotton in the gin.

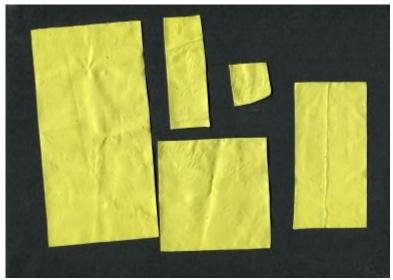
Figure 3. Pieces of JD module wrap, both layers attached, after testing.

Figures 3, 4, 5, and 6 show photographs of some of the plastic retrieved from the waste or lint during the study. Some pieces were not damaged by the processing and others were considerably changed.

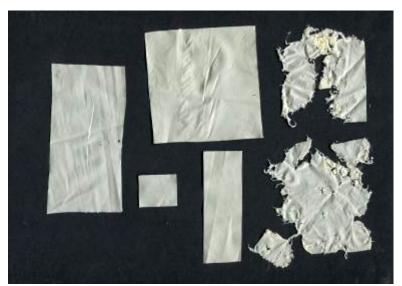
Figure 4. Pieces of the opaque inside layer of JD module wrap after testing.

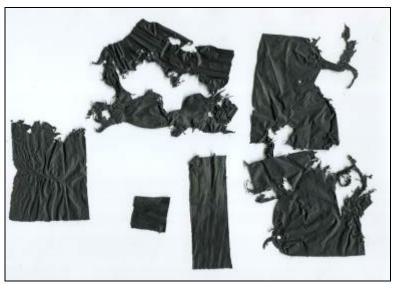
Figure 5. Pieces of agricultural plastic mulch after testing.

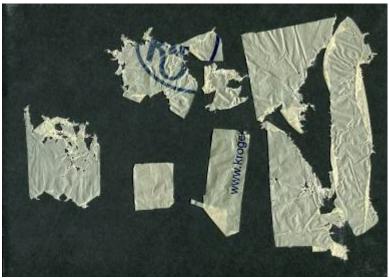
Figure 6. Pieces of shopping bag after testing.
