## FIELD EVALUATION OF THE VIPR™ SYSTEM

Ross D. Rutherford  
Lummus Ag Technology  
Lubbock, TX  
Gabe J. Sweers  
Bratney Companies  
Des Moines, IA

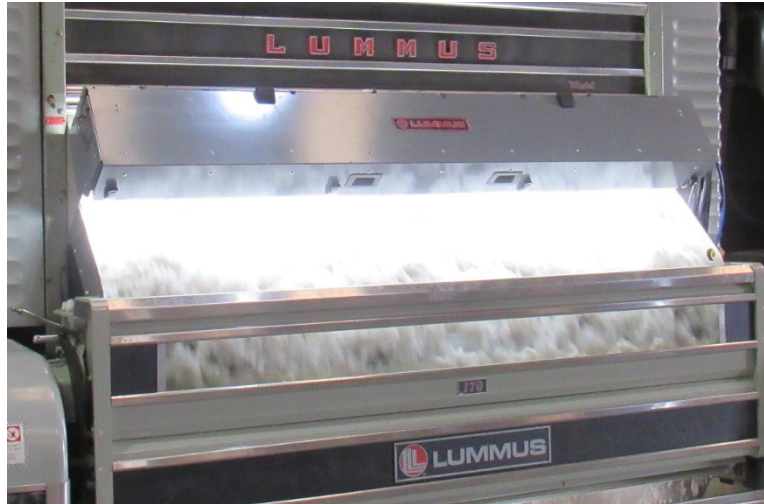
Figure 1. VIPR™ system on Model 700 Feeder at Southeastern Gin & Peanut, Inc.

The VIPR™ system uses RGB cameras and air knives in an assembly mounted over the feeder apron of the extractor feeder located directly above the gin stand. Figure 1 shows a typical installation of the camera cabinet assembly, while Figure 2 shows the cameras within the cabinet.

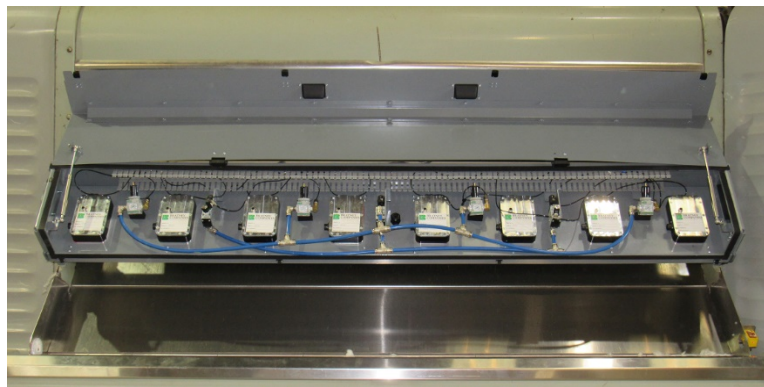
Figure 2. VIPR™ camera assemblies in cabinet (cover raised).

The VIPR™ system operates under the following concept/method. Cameras are mounted across the entire feeder apron (e.g., eight cameras on a 96" wide feeder), and each camera views approximately 14" of apron width (so there is a small overlap of coverage). Every pixel is analyzed to determine color, and based on color, the computer software sorts every pixel, categorizing it as either "good" or "bad." "Good" is considered as being anything that "looks" like cotton, stainless steel (the background of the feeder apron), and shadow area (area untouched by sufficient light to determine color). A "reject" is what is considered contamination or foreign material and comprises all the colors outside the profile. If there are enough "reject" pixels next to each other, the software algorithm classifies the pixel cluster as an object to remove. Based on the location on the apron, the computer decides which air knife (or knives) to fire in order to effectively remove the contamination. The air knives then release a blast of compressed air to remove the contamination. Air knives are set to turn on at the earliest possible time the contamination could be at the blast zone and turn off at the latest possible time the contamination could be in the blast zone. Collateral product removal is unavoidable but justified by the relative importance of removing contamination.

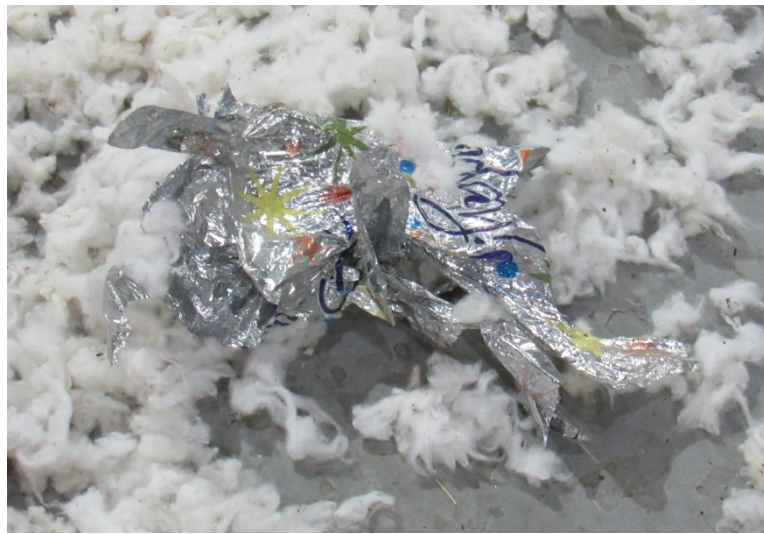
Figure 8. Mylar® balloon detected and ejected by the VIPR™ System.

In a side note to the actual testing of the VIPR™ system, at the conclusion of one of the replications, a silver and multi-colored Mylar® party balloon was detected and ejected from Gin #1, and it is shown in Figure 8.
