ROUND MODULES: HANDLING LOGISTICS AND COVER DAMAGE**Tianyi Wang****Robert G. Hardin IV****Texas A&M University****College Station, TX****Jason K. Ward****North Carolina State University****Raleigh, NC****John D. Wanjura****USDA ARS****Lubbock, TX****Abstract**

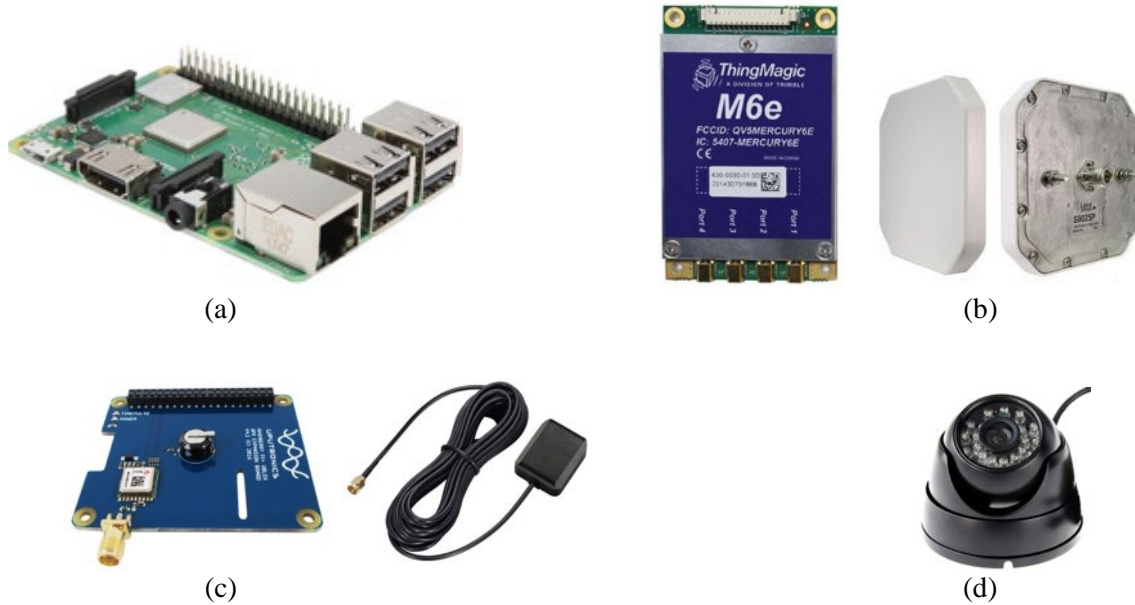
Figure 1. The smart cotton module tracking system contains (a) data logging CPU, (b) RFID module, (c) GNSS module, and (d) cameras.

A smart cotton module tracking system was designed and built for tracking cotton modules and recording damage on the wrap. The system contains four main parts, which are the central processing unit (CPU), RFID module, GNSS module, and cameras (Figure 1). The CPU, a Raspberry Pi 3b+, logs all collected data every three seconds. Three cameras are used to collect images of each module on loaders and tractors, while four are needed on a module truck to capture images of most of the module. The images were collected from the cameras beginning when the loader slowed down to load and unload the cotton modules.

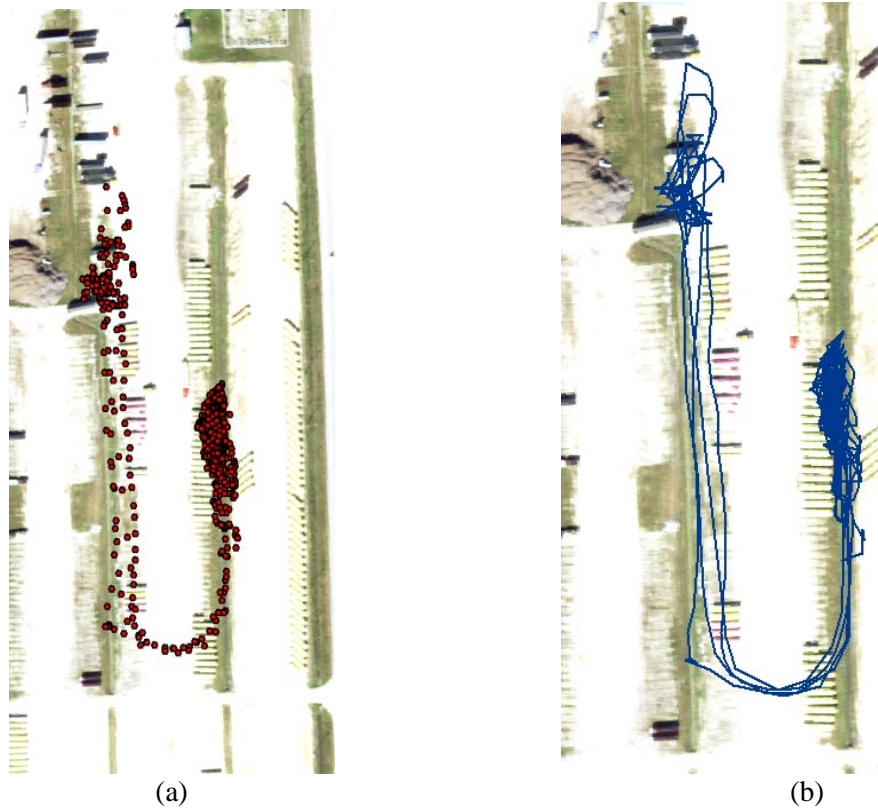
Figure 4. GNSS points (a) and the polyline (b) indicating the loader route on Sept. 26.

An 80-min. working period on Sept. 26, 2019 was used as an example. The loader was in the gin yard to unload the cotton modules from a flatbed trailer on the gin yard. A total of 619 images with GPS coordinates were collected during this period. Each GNSS point was sequentially linked to form a polyline to indicate the moving route of the forklift (Figure 4). The results indicated that the forklift was driven a total of 4.856 km during unloading. In a second sample period on Sept. 27, there were 374 images captured in 55 minutes. The forklift was driven a total of 5.375 km (Figure 5). Additional time and motion data will be analyzed to determine cycle times for unloading modules.

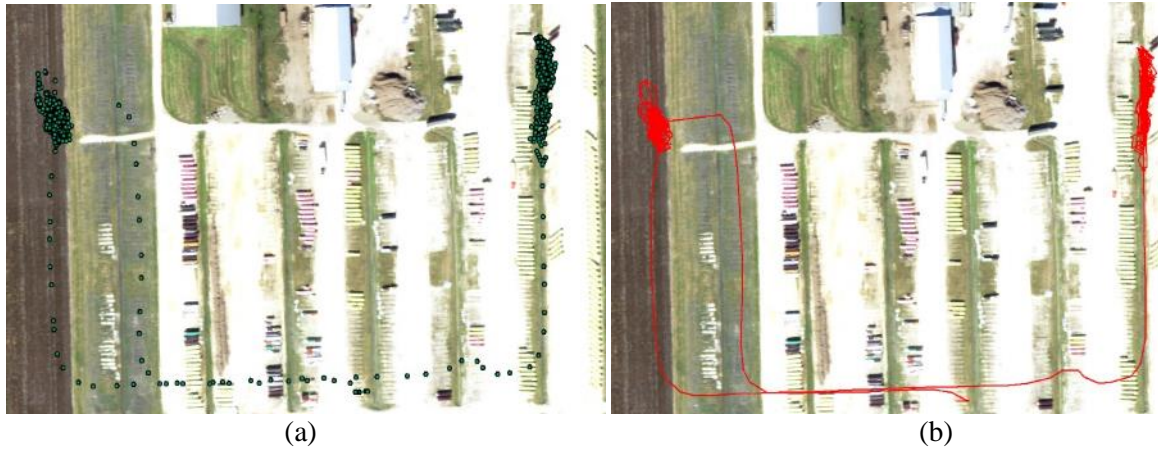
Figure 5. GNSS points (a) and the polyline (b) indicating the loader route on Sept. 27.
