## PLASTIC REMOVAL AT THE MODULE FEEDER

K. Clark

R.G. Hardin IV

Texas A&M University  
College Station, Texas

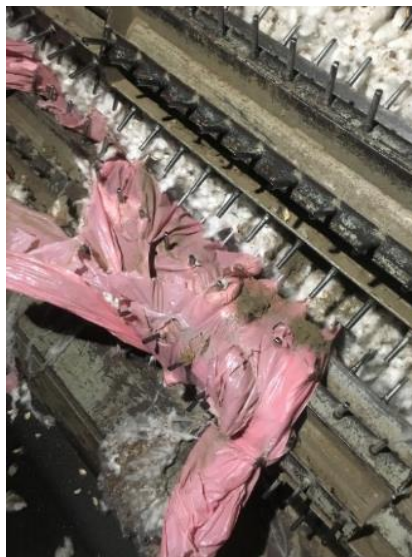
For cotton growers and ginner in the US, producing a high-quality end product with no contamination has been an ongoing focus. This goal is evidenced by the fact that US cotton has been found to be some of the least contaminated in the world (International Textile Manufacturers Federation, 2016). However, losses due to contamination are estimated at a staggering \$200 million per year worldwide (van der Sluijs and Hunter, 2017). While improperly disposed of garbage, such as plastic bags, and other sheet plastic contamination are a concern, the primary source of plastic contamination in the US is plastic round module wrap. While the original harvester with onboard round module builder was introduced quite some time ago, and there are many commercially available systems for removing the wrap at the gin, these systems do not always work flawlessly. This could be due to an inexperienced module unwrapper operator, damaged equipment, or improper module handling practices. If the plastic is not successfully removed before the module is fed into the gin, large pieces of the plastic are wound on the dispersing cylinders of the module feeder, and if not removed immediately, can shed smaller pieces that will end up in the cotton bale. Plastic wrapped around a module feeder cylinder can be seen in figure 1.

Figure 1. Module wrap on module feeder dispersing cylinder.

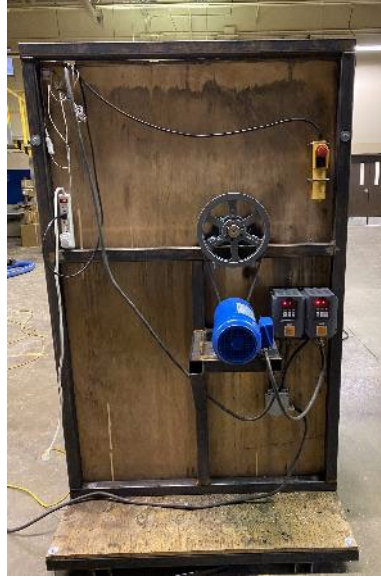
The dispersing cylinder used was designed and manufactured by Lummus (Savannah, Ga.). Cylinder dimensions were identical to commercial Lummus module feeder cylinders, except the cylinder was designed for a module feeder with a 76.2 cm (30 in.) inside width. A 30.5-cm (12-in.) single groove v-belt sheave was attached to one end of the cylinder axle and connected via a v-belt to a 1.5 kW (2 hp) motor with a 7.6-cm (3 in.) sheave mounted below the shaft of the dispersing cylinder on the outside of the housing assembly. The motor was then connected to a variable frequency drive (VFD) to allow for rotational direction and speed changes. This system can be seen in figure 3.

Figure 3. Dispersing cylinder drive.

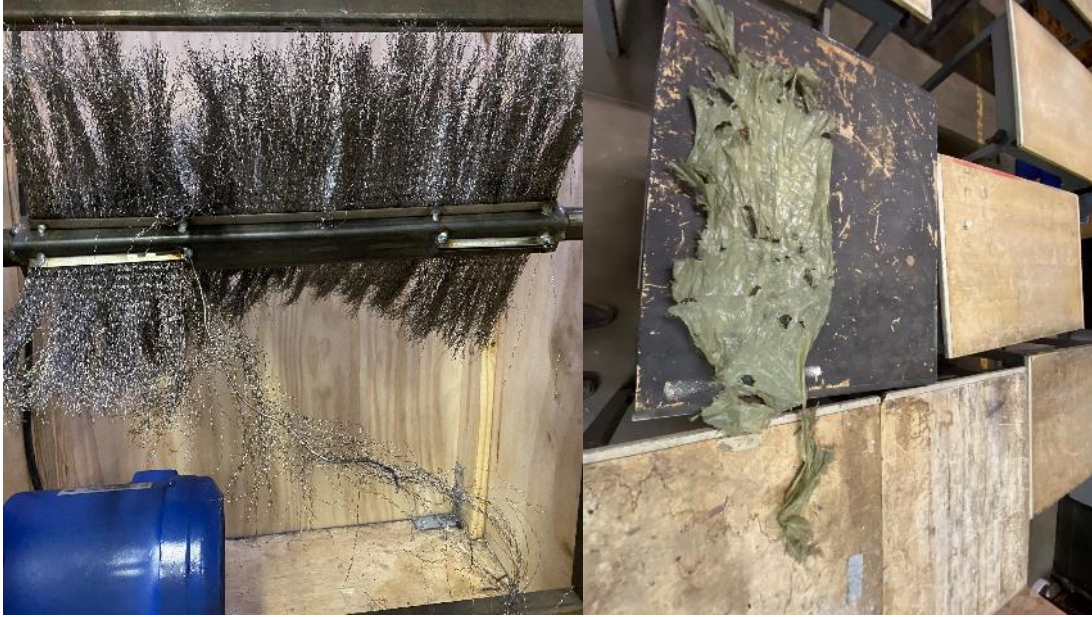
The stainless steel brush showed promise in removing plastic, as the piece was removed without excessive shredding (figure 6a). Unfortunately, the brush failed early in testing, so evaluation of different process parameters could not be completed (figure 6b). Failure occurred in the backing of the strip brush, not the actual brush wire. The backing deformed, and the wire was no longer held in the backing.

Figure 6. Failed brush assembly (a) and removed plastic (b).

A stainless steel brush cylinder was designed and constructed that removed plastic from a module feeder dispersing cylinder. This concept will be evaluated in future testing to optimize system parameters; however, an improved brush design is needed. Forces applied during testing caused rapid failure of the strip brush backing. Reinforcement or redesign of the backing will be done before additional testing.
