AN INTEGRATED MODULE FEEDER MONITORING SYSTEM TO MITIGATE PLASTIC CONTAMINATION

Abstract

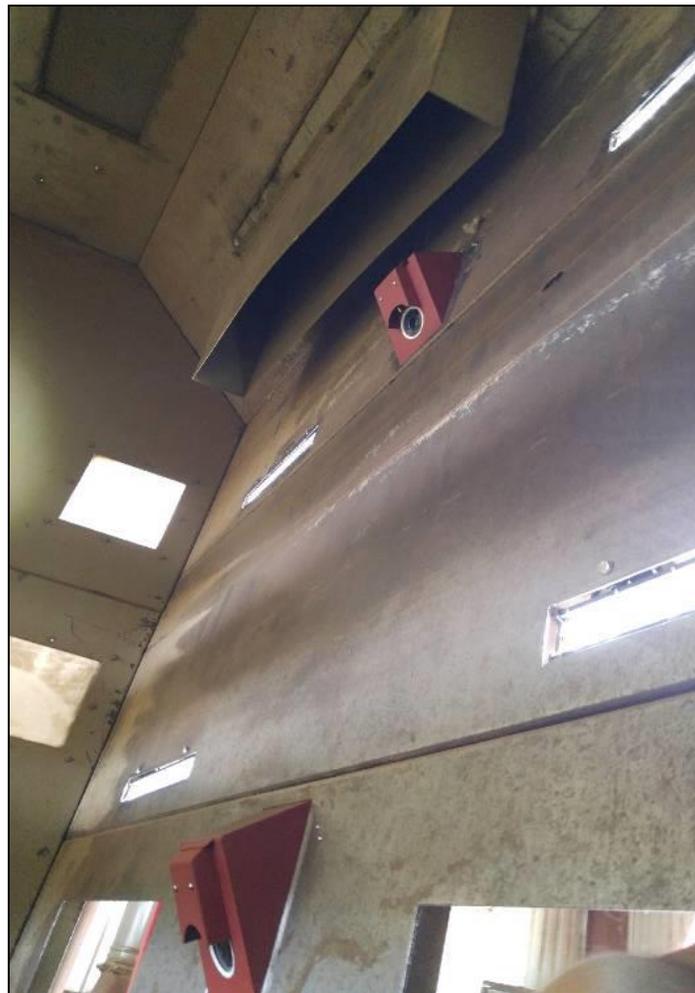
Figure 1. Photo of USDA ARS Module Feeder Inspection System IP cameras installed in back wall of module feeder dispersing cabinet at Gin A.

The USDA Module Feeder Inspection system (Pelletier et al., 2020) was installed in the dispersing cabinet of the module feeder (figure 1) and collected still images of the dispersing cylinders when the feeder floor was manually paused and sufficient time had elapsed to allow cotton and dust to fall out of view of the internet protocol (IP) cameras. A beta version of the image capture software for the USDA Module Feeder Inspection System was used in 2019. Two cameras were used to monitor the upper and lower dispersing cylinders of the feeder. With a clear camera view of the dispersing cylinders, the ginner pressed a button on the system display (figure 2) located in the gin console room to capture the still images. Live video streams from the two cameras were also displayed on the monitor and allowed the ginner to see plastic accumulation on the cylinders often before still images were captured. Each time plastic was observed on the dispersing cylinders, the gin crew quickly stopped the module feeder, removed the plastic, and placed it in a container labeled with the date and time of removal. A research team member visited the gin several times each week and conducted further analysis of the plastic to identify from what part of the wrap portion the material originated, how much material was collected, and identification number of the module from the RFID tag(s) if present.

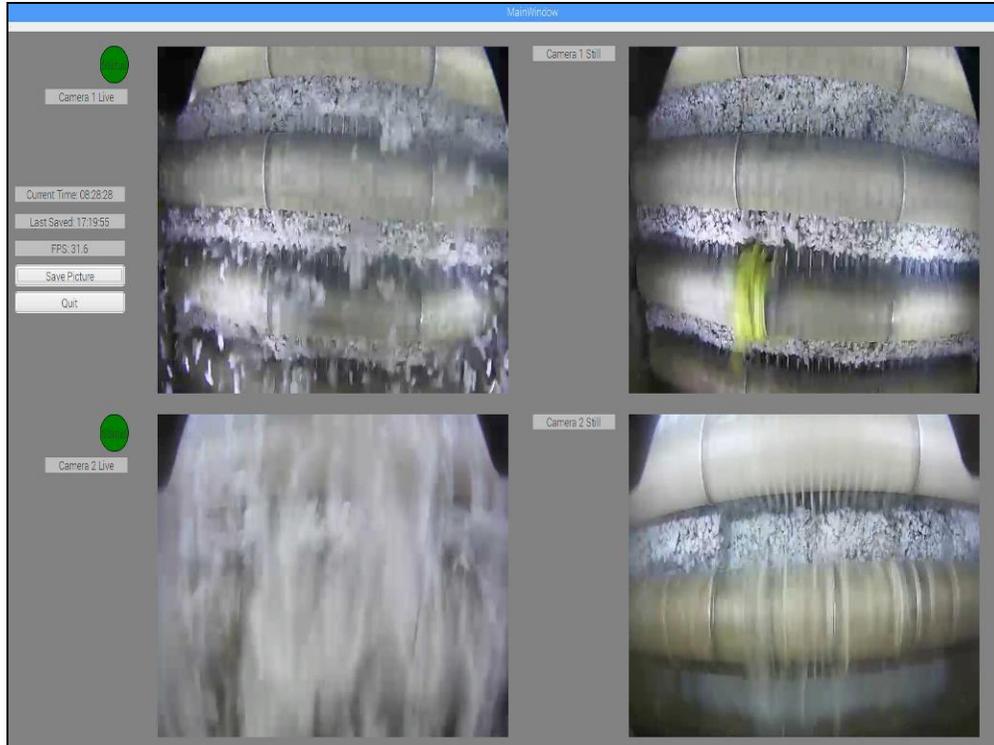
Figure 2. USDA ARS Module Feeder Inspection System display showing live video feeds from top and bottom cameras (top and bottom left side images) installed in the dispersing cabinet along with the latest still images (top and bottom right side images) captured of the dispersing cylinders.

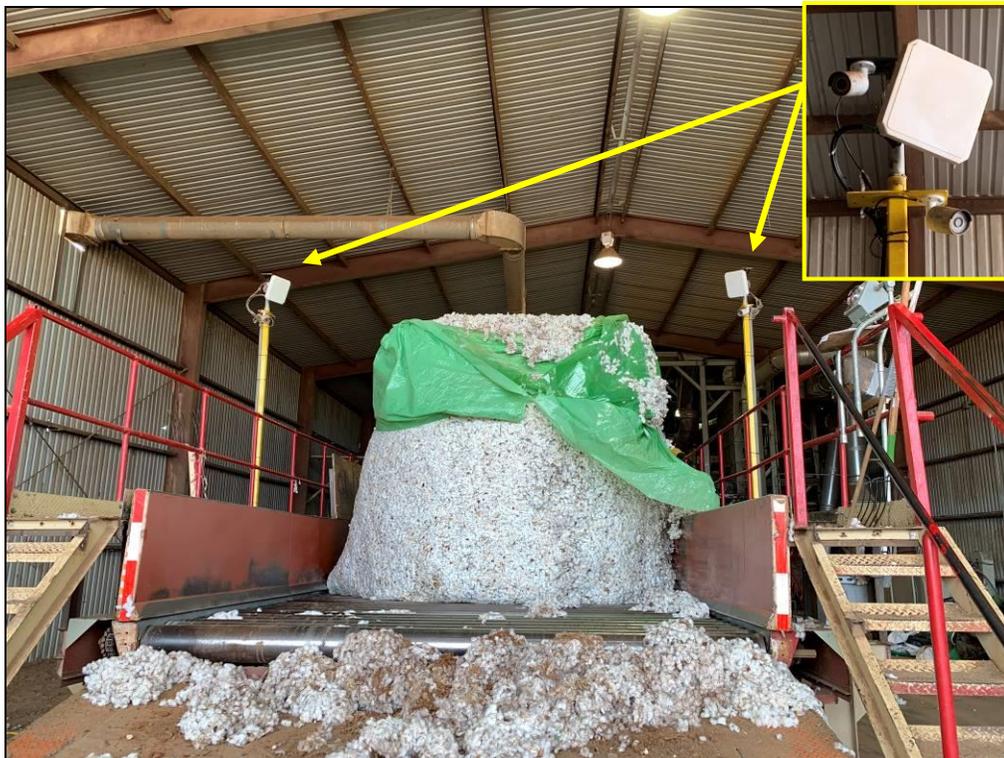
Figure 3. Photo of the RFID Feeder Bridge antennae and NVR IP cameras mounted on top of the yellow poles on both sides of the module feeder bed.

At the end of the module feeder where modules are placed on the feeder bed, an RFID scanning bridge was installed along with a network video recording (NVR) system (figures 3 and 4). The RFID Feeder Bridge system developed by Wanjura et al. (2020b) was used to scan the RFID tags on each round module as it was unloaded onto the module feeder bed and create a processing log for all round modules ginned. The serial number, wrap color, and other module specific data for each module wrap portion used in the experiment was loaded into the RFID scanning system database before the ginning season. This data was recorded with the date and time that the module was

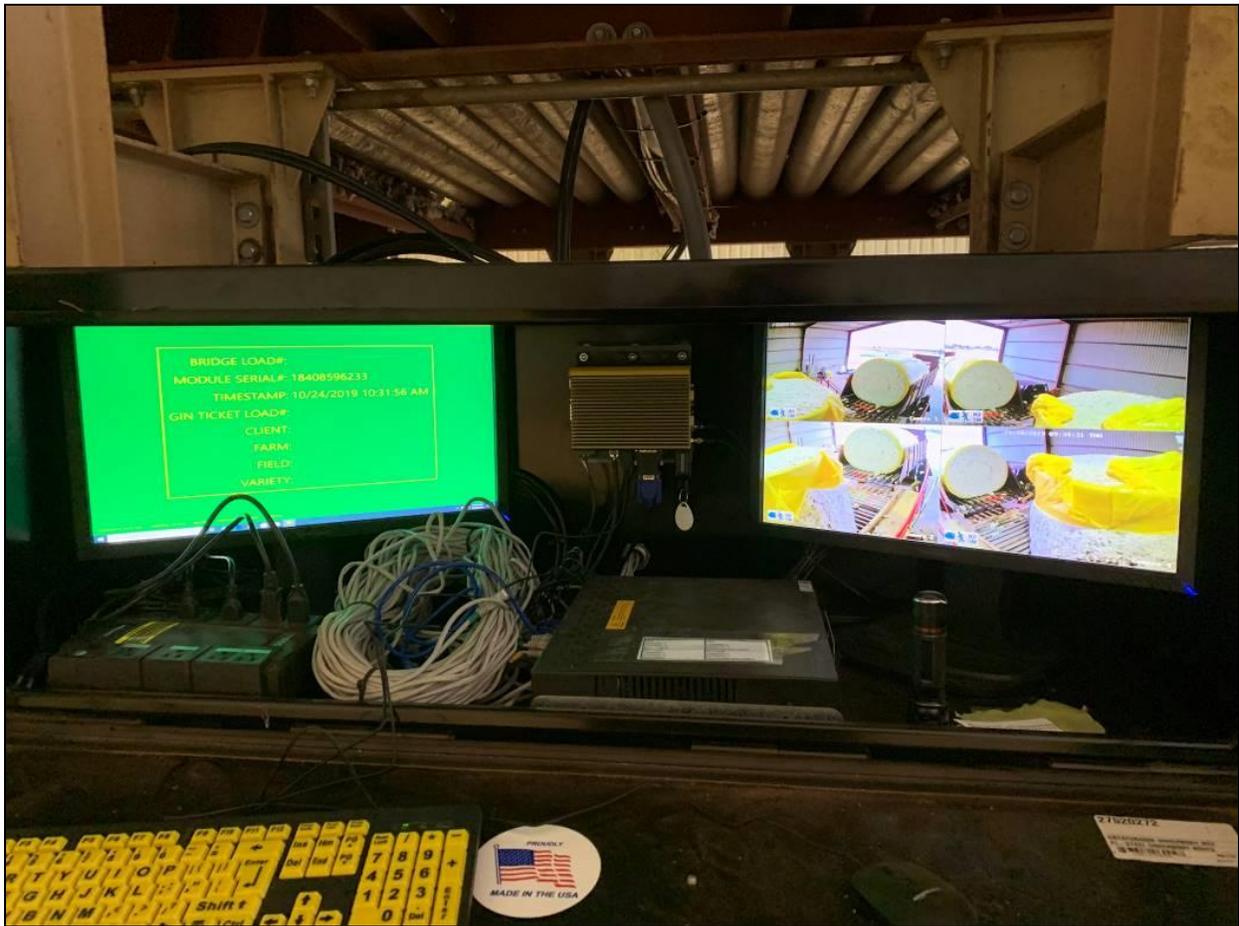
Figure 4. Photo of the enclosure box mounted below the module feeder bed at Gin A that housed the electronics and displays for the RFID Feeder Bridge (left display) and NVR (right display) systems.

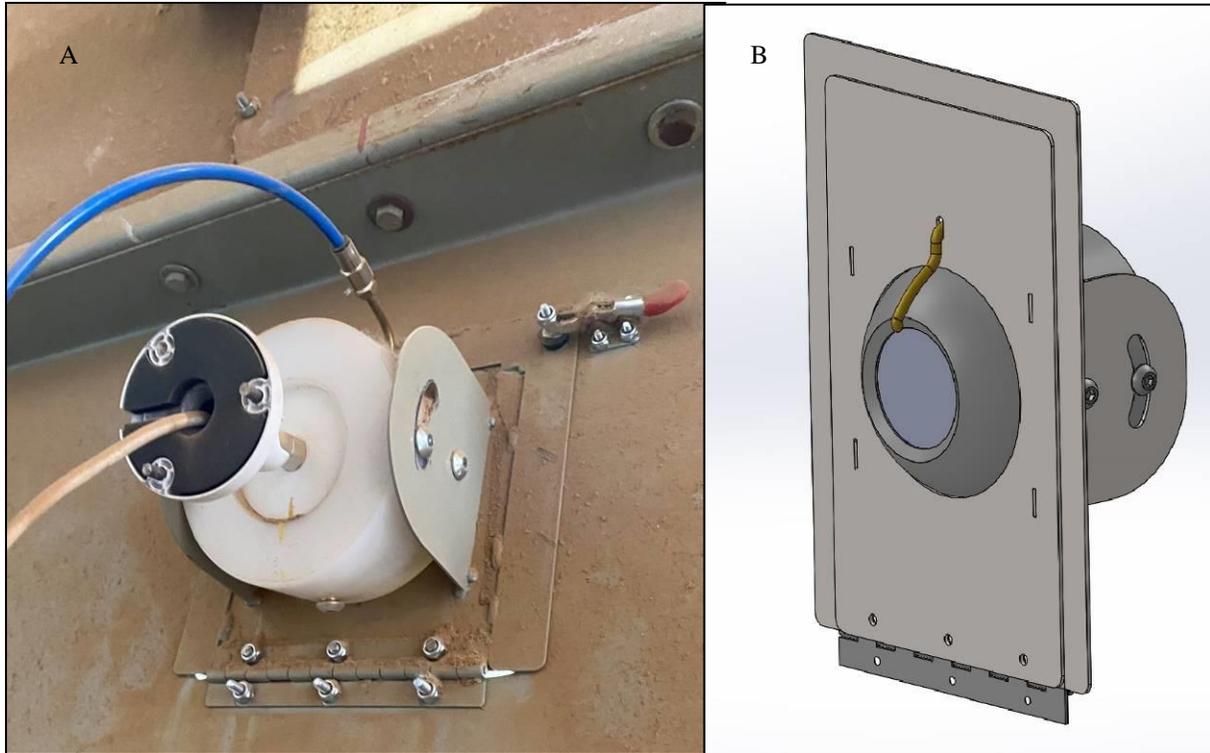
Figure 5. Ball face camera mount installed at Gin B (A) and design model (B).

The module feeder monitoring system used in 2019 was modified in 2020 and installed at Gin A and at a second ginning facility in the Texas High Plains, Gin B. The new module feeder monitoring system was designed such that the three independent data collection systems originally installed on the module feeder at Gin A were integrated to operate on one PC and store the data in a common location on a 2 TB portable solid-state drive. The USDA ARS Module Feeder Inspection software was recompiled to run on Windows 10 and was modified to allow still image captures based on the module feeder run signal status. A timing routine was written into the PLC software controlling the module feeder bed at both gins to automatically pause the feeder bed for a ginner specified time period and frequency. The bed pause duration was approximately 11 s at both gins and occurred once every 30 min. A dry-contact relay was actuated by the PLC during the bed pause event, signaling the USDA Module Feeder Inspection software to capture still images from the IP cameras mounted in the dispersing cabinet (figure 5) at the end of the bed pause event. The USDA ARS Module Feeder Inspection software created a data file that contained the bed pause event number, timestamp, and the file pathnames for the still images from both IP cameras. New ball-faced mounts were designed and installed for use with the USDA Module Feeder Inspector system cameras at both gins in 2020. The new camera housing allows for +/- 30 degrees of camera elevation adjustment allowing the cameras to be positioned as needed on the dispersing cabinet back wall regardless of dispersing cabinet design (figure 5). Additional software changes were incorporated that allowed for automatic detection of plastic on the dispersing cylinders via machine vision analysis of the camera images. Additional work is ongoing to improve the performance of the automatic detection feature of the software because operation of the system revealed that sufficient and uniform lighting of the dispersing cylinders is critically important for optimal automatic classification of plastic on the dispersing cylinders.

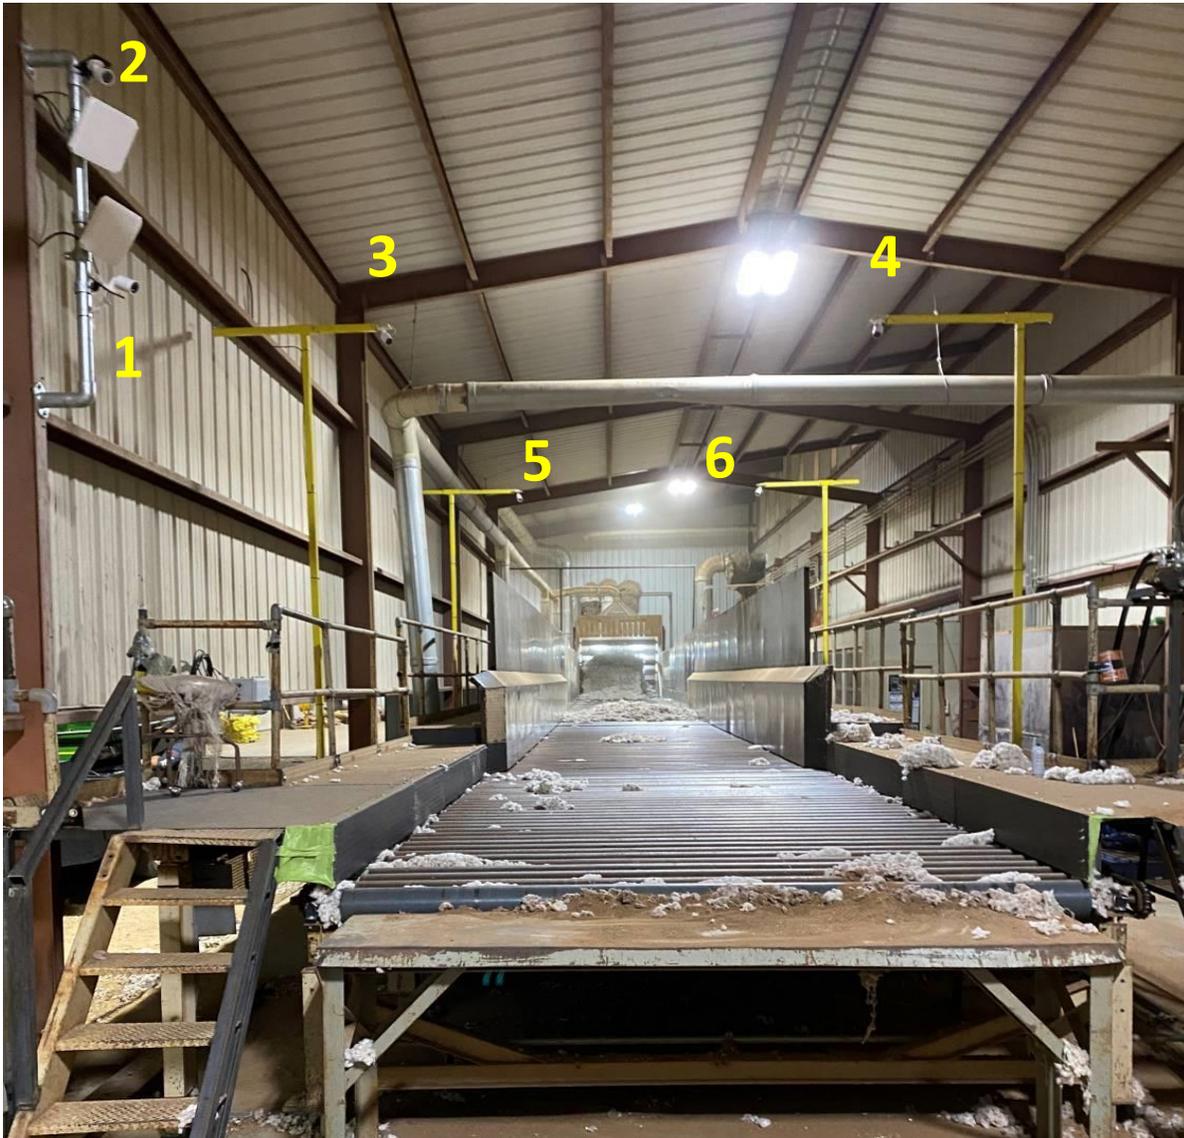
Figure 6. Photo showing numbered camera positions used on the module feeder at Gin B in 2020. RFID antennae are located between camera positions 1 and 2.

The RFID Feeder Bridge software was modified to allow the collection of video data from six IP cameras. The six camera positions used at Gin B are shown in figure 6 and the cameras were positioned similarly on the module feeder at Gin A in 2020. Each camera was connected to a power over ethernet (POE) network switch that provided power and data transmission for each camera. The IP cameras were configured to stream real-time data back to the PC at 7 frames per second and the video streams were stored in a temporary data buffer. When the RFID tags on a module being placed on the feeder were scanned by the system, the software recorded the timestamp of the scan event and later extracted video data from each camera for a specified period before and after the RFID scan event. The video data segment was stored on the portable SDD on the local PC with the filename including the module serial number (from the RFID tags), date/time stamp, and camera number.

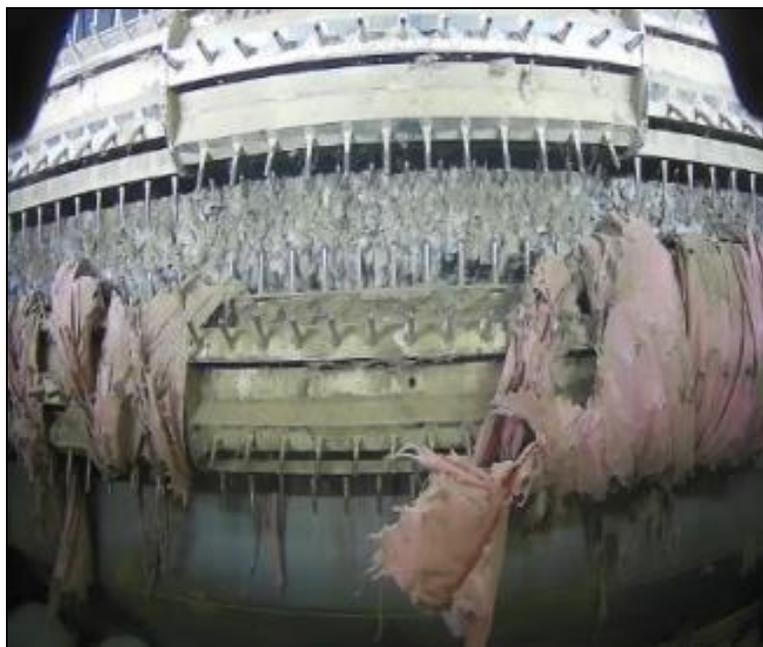
Figure 7. Lower dispersing cabinet camera still image of pink plastic caught on bottom dispersing cylinder.

A total of 77 potential contamination incidents were documented at the module feeder at gin A in 2019. The gin processed a total of 41,236 bales and had 18 plastic calls. Images analyzed for one potential contamination event that occurred on 10 November 2019 are shown in figures 7, 8, and 9. In this instance, pink module wrap was caught by the bottom dispersing cylinder as seen in the lower camera image (figure 7). Upon removal from the cylinder, the plastic did not contain an RFID tag or any other means of identifying the specific module from which the plastic originated (figure 8). Additional green plastic was removed from the dispersing cylinders and stored in the same container as the pink wrap. The pink module wrap color was used to review the RFID scanning log and determine when modules with pink wrap were placed on the feeder. Using the RFID scan event date and time, the video of the unloading and unwrapping events for the most recent pink modules placed on the feeder were reviewed and revealed an unloading mishap for the module shown in figure 9. The module fell backward toward the truck when it was unloaded, trapping a portion of the wrap material between the cotton and the feeder bed rollers. The gin crew was unable to completely remove the trapped module wrap (figure 10) and the remaining portion was caught by the dispersing cylinders.

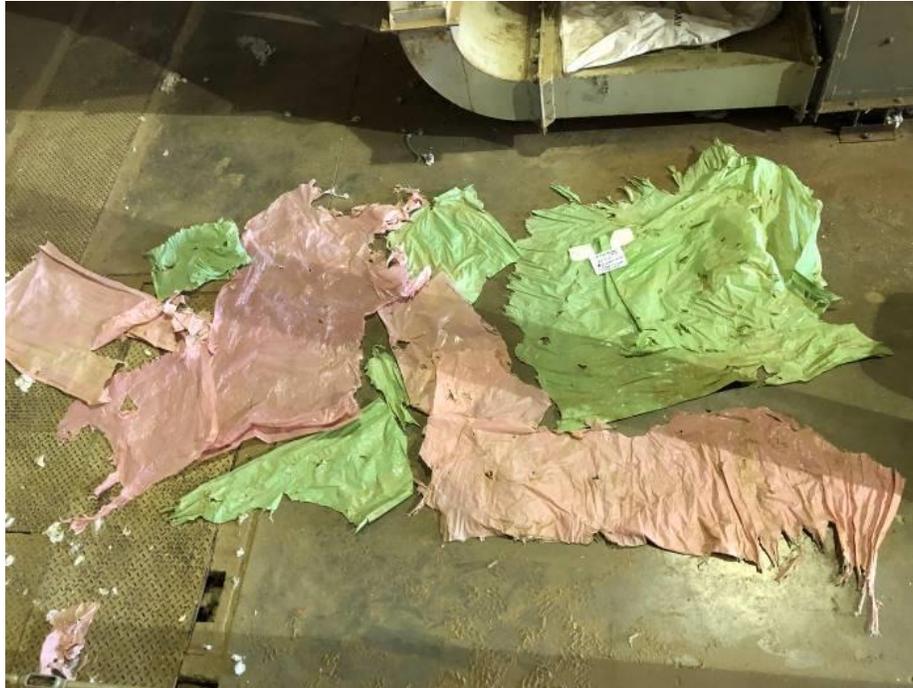
Figure 8. Pink plastic removed from lower dispersing cylinder by gin crew after detection via dispersing cabinet camera image. Pink plastic stored with green plastic removed at the same time from other dispersing cylinders.

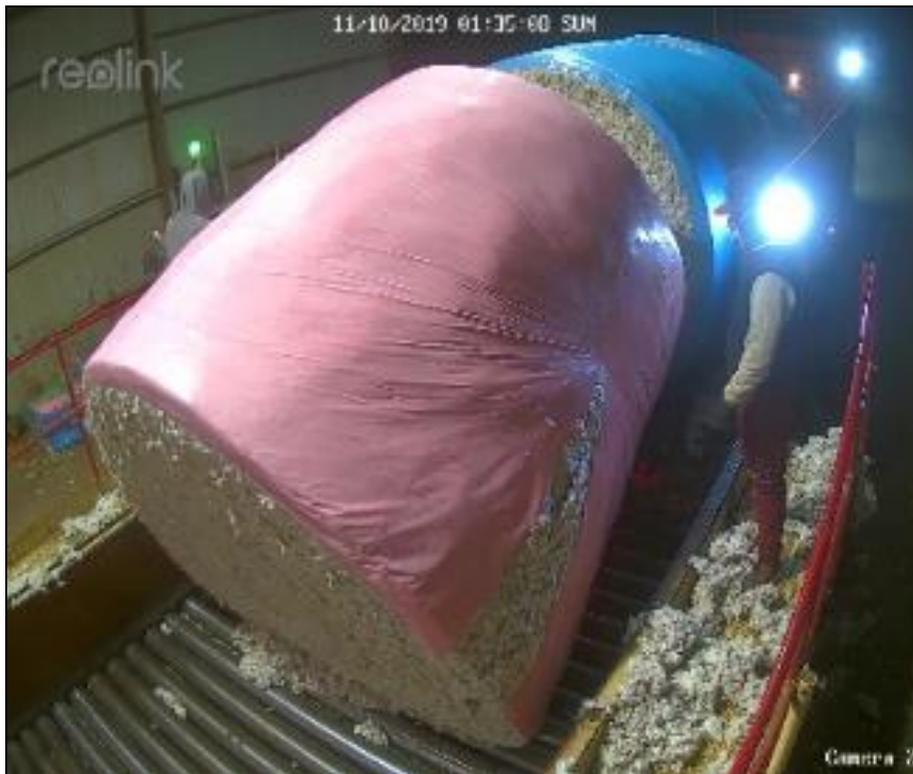
Figure 9. Image taken from the unloading video captured for the pink module in view (camera 2). The video showed that the module fell backward onto the truck and module feeder bed trapping a portion of the wrap material underneath the cotton.

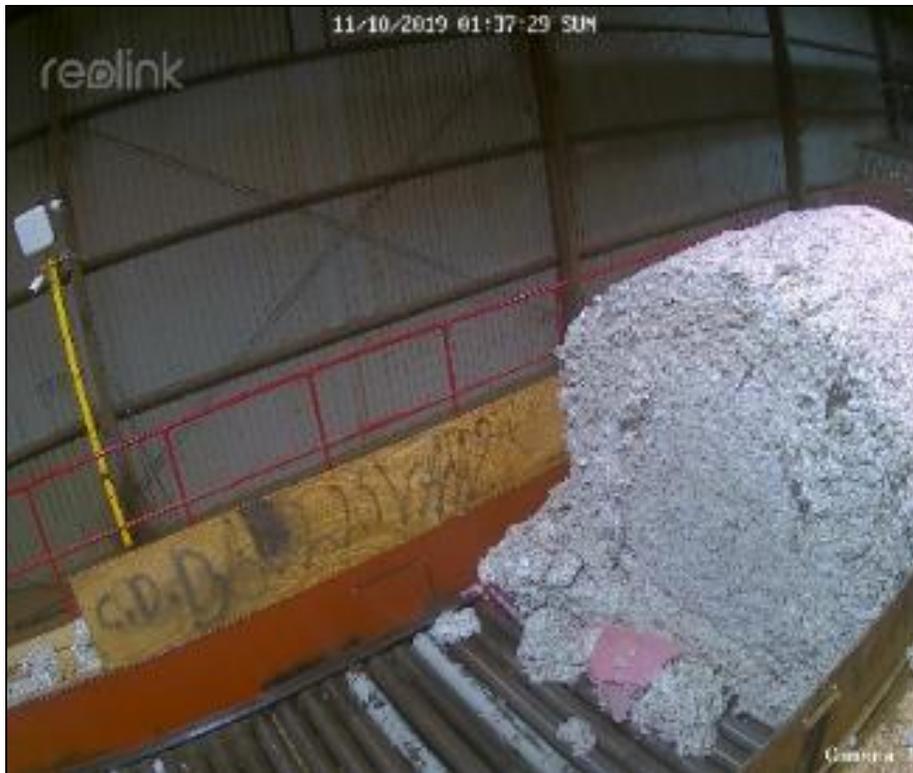
Figure 10. Image taken from the module unloading video (camera 4) showing plastic remaining under the cotton after attempts to remove the trapped material.

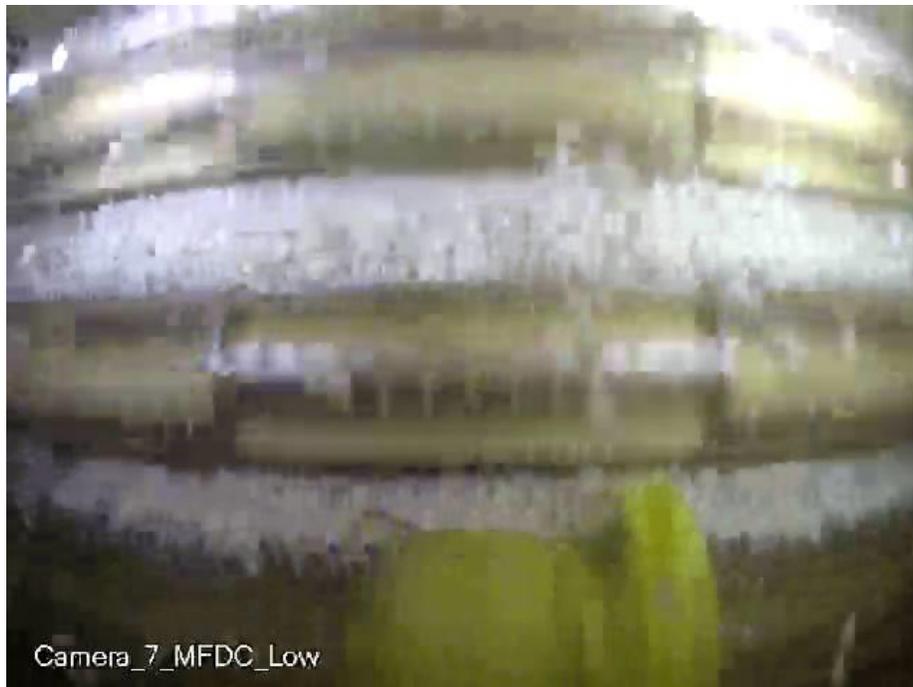
Figure 11. Image of yellow plastic on lowest dispersing cylinder at Gin A in 2020.

In 2020 the new integrated module feeder monitoring system captured data for 19 potential contamination events at Gin A. The regional crop was considerably smaller in 2020 compared to 2019 due to lack of rainfall. Gin A processed 18,133 bales in 2020 and had 7 bales called with plastic contamination. An example of one potential contamination event captured by the integrated module feeder monitoring system at Gin A in 2020 is shown in figures 11 – 13. In this event, yellow module wrap plastic was caught by the lowest dispersing cylinder as seen in the image from the bottom module feeder cabinet camera (figure 11). Upon removal of the plastic from the dispersing cylinder, the module was identified by serial number 19410229688 from the RFID tag found on the plastic. Because of the presence of the RFID tag, the material was identified as part of the inside opaque leading portion of the wrap material that does not contain tacky layer adhesive. Using the module serial number, the unloading/unwrapping video for the module was directly extracted and viewed. The video showed that the module was unloaded properly with no issues and the plastic was cut and pulled to the top of the module as is standard practice at Gin A. However, when the wrap was finally cut and removed from the module as it reached the midpoint of the module feeder, a piece of the yellow material fell between module 19410229688 and the previously unloaded module. The workers were unable to see the plastic in the cotton between the modules as a portion of the cotton from 19410229688 fell burying the plastic.

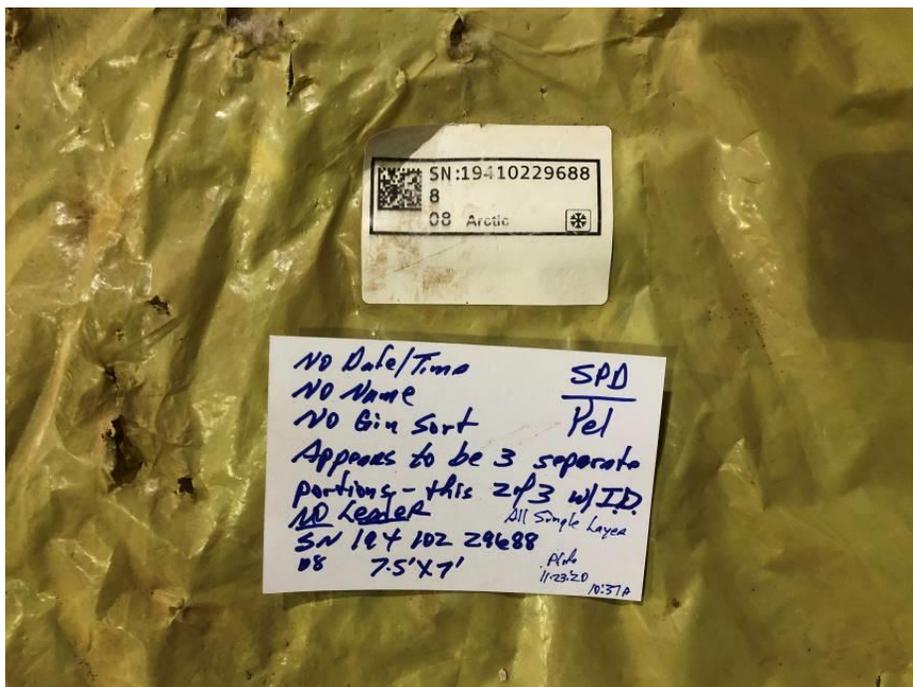
Figure 12. Image of yellow plastic removed from lowest dispersing roller (figure 10) showing RFID tag with serial number 19410229688 that was used to identify the module from which the plastic originated.

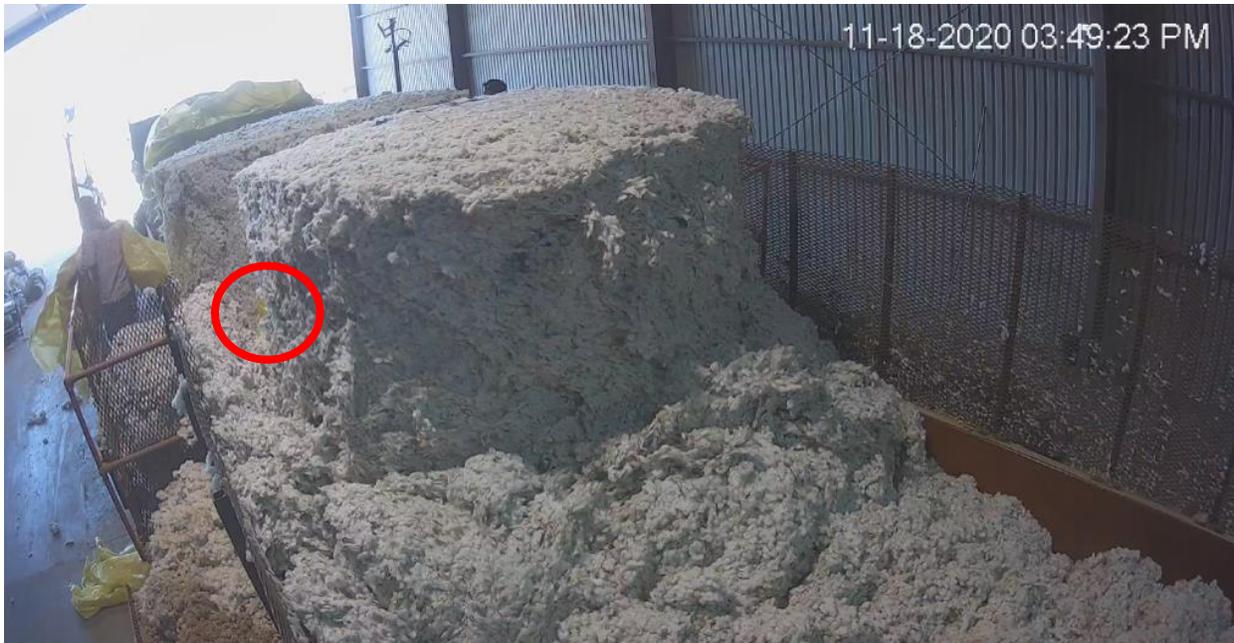
Figure 13. Still image from the unloading video captured for module SN 19410229688 showing piece of yellow plastic remaining in cotton between modules after wrap was removed from the top of the module.

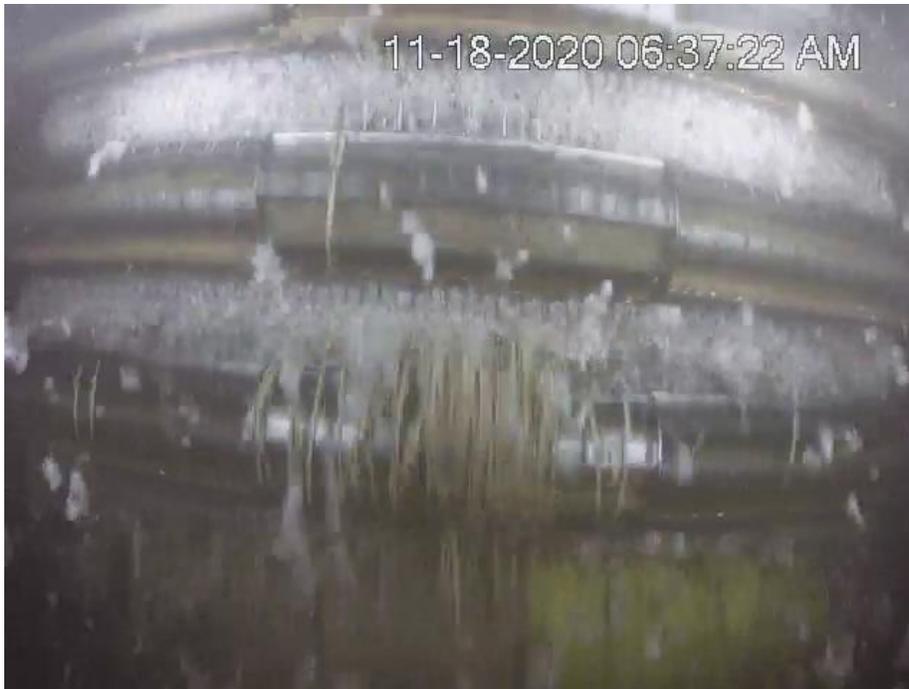
Figure 14. Image of yellow module wrap plastic caught on lower dispersing cylinder at Gin B. White twine on middle cylinders originates from rectangular modules. The white twine is used to restrain tarps on rectangular modules and is often not completely removed from the module prior to processing. However, accumulation of this material on the cylinders tends to remain on the cylinders without wearing off to cause contamination.

In 2020, the integrated module feeder monitoring system captured data for 37 potential contamination events at Gin B. Gin B processed 61,782 bales in 2020 and had 14 bales called with plastic contamination. An example of one potential contamination event captured by the integrated module feeder monitoring system at Gin B is shown in figures 14-16. In this event, yellow module wrap plastic was caught by the lowest dispersing cylinder as seen in the image from the bottom module feeder cabinet camera (figure 14). The second cylinder from the bottom in figure 14 shows white twine accumulation on the cylinder. This twine is used to restrain conventional module tarps in the field and is often not removed from the dispersing cylinders frequently because it poses little contamination risk as it doesn't wear off with processing time. Upon removal of the yellow plastic from the dispersing cylinder, the module was identified by serial number 19403248068 from the RFID tag found on the plastic (figure 15). Using the module serial number, the unloading/unwrapping video for the module was directly extracted and viewed. The video showed that the worker cut the module wrap just ahead of the module truck tail shaft as is common practice at Gin B. In this case, the cut was positioned about 20 in below the white separation tag on the outside of the module. When the module was rolled off the truck onto the feeder bed, the module wrap fell out of the unwrapping system and was trapped under the cotton when the module rolled backward slightly (figure 16). The video showed that the workers removed most all of the trapped module wrap plastic, but an 8.3 ft x 5.7 ft piece remained in the cotton (which contained the identifying RFID tag) and was caught on the lowest dispersing cylinder.

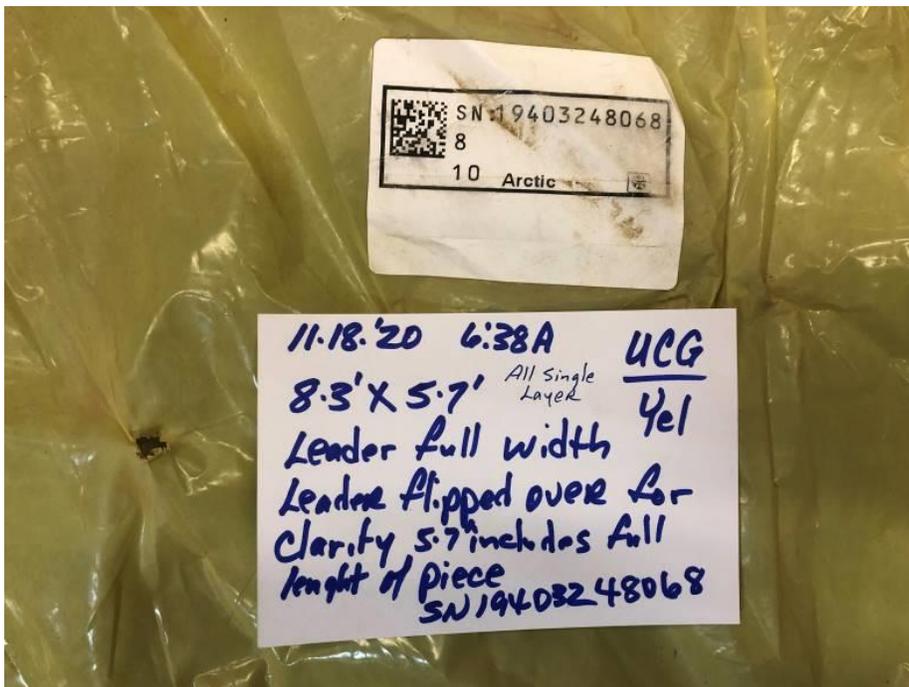
Figure 14. RFID tag and plastic size information collected after the plastic was removed from the dispersing cylinder at Gin B.

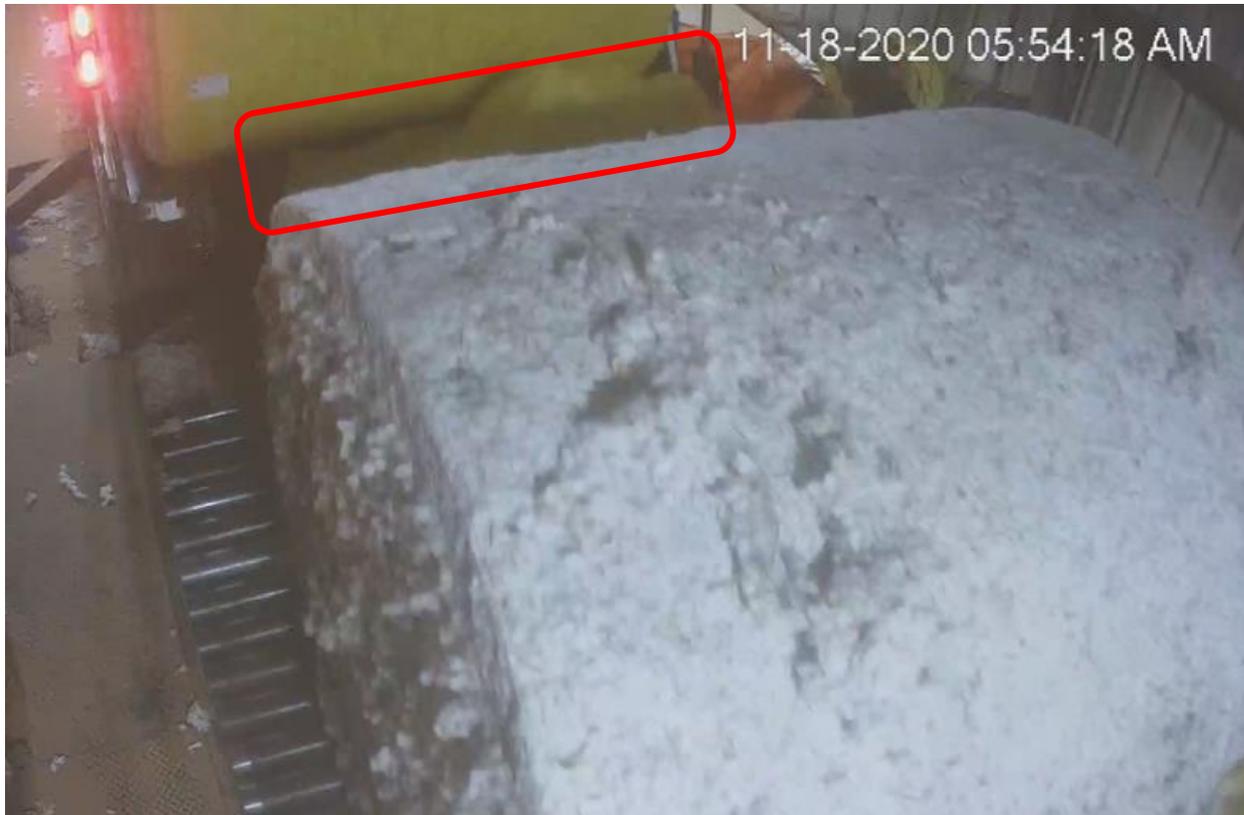
Figure 16. Image collected from the unloading video for module serial number 19403248068 showing module wrap trapped under cotton after the module was unloaded from the truck at Gin B.
