THE POWERED ROLL GIN STAND A GIN'S PERSPECTIVE

James W. Askew

Servico, Inc.

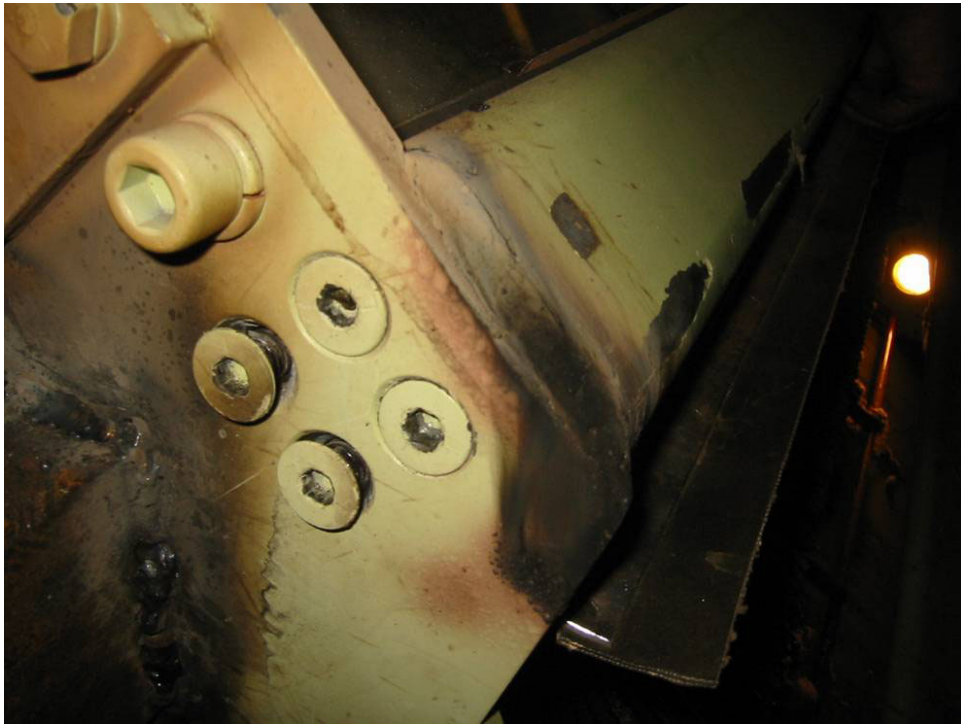
Figure 4. Welded Power Roll gin stand rib rail.

shaft breakages, twisting of rib rail resulting in the relocation of gin rib positions, power roll flaps breaking from power roll shaft, and power roll drive cog belt breakages. Each of these problems was addressed and resolved during the gin season. The power roll drive shaft breakages were corrected by installing stronger stand-offs for the drive shaft bearings (Figure 3). The twisted rib rails were moved back into position and welded at each end to assist the originally installed bolts in the support role (Figure 4). Gussets were installed between power roll flaps to enhance the structural integrity of the entire power roll (Figure 5). Cog belts internally lined with Kevlar material were installed to prevent premature breakage of the belts.

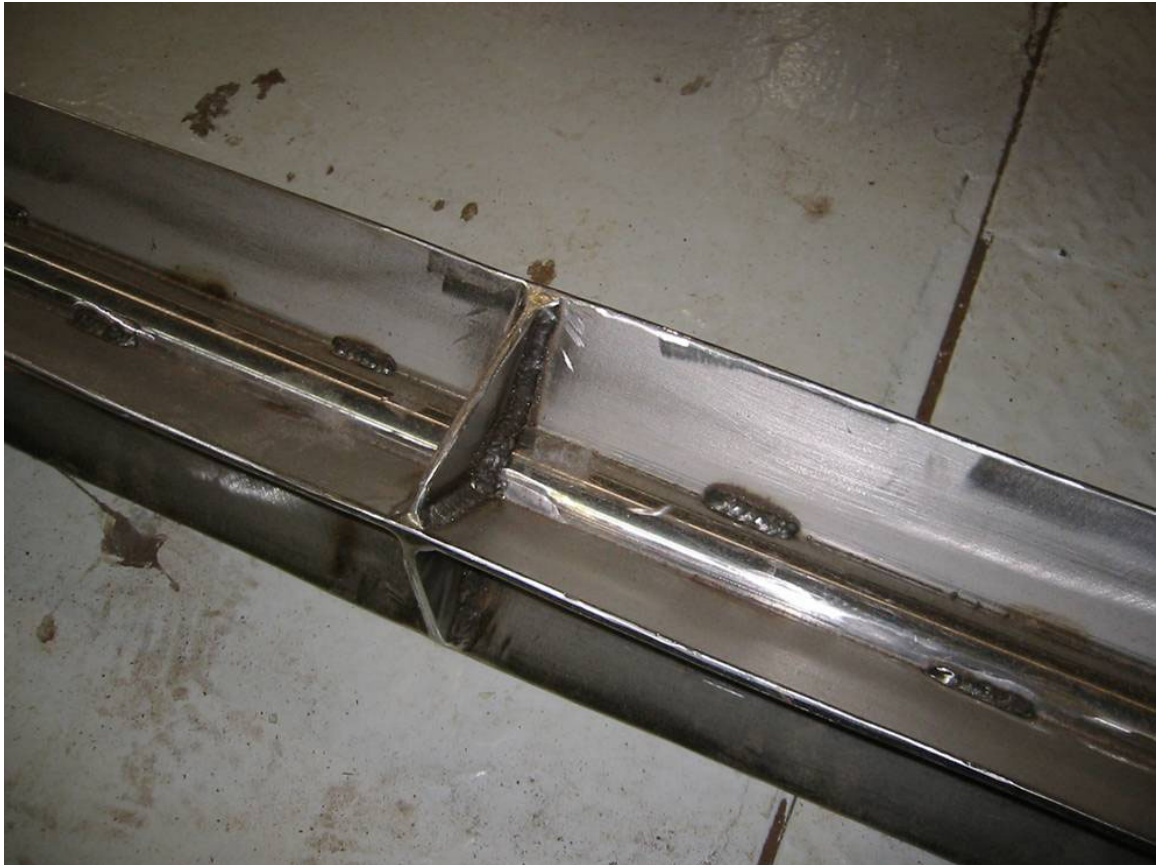
Figure 5. Gussets added to Power Roll gin stand power rolls.
